**SIA "Mikrotikls"**

## Testing methods of RB Ethernet ports which are damaged by over voltage

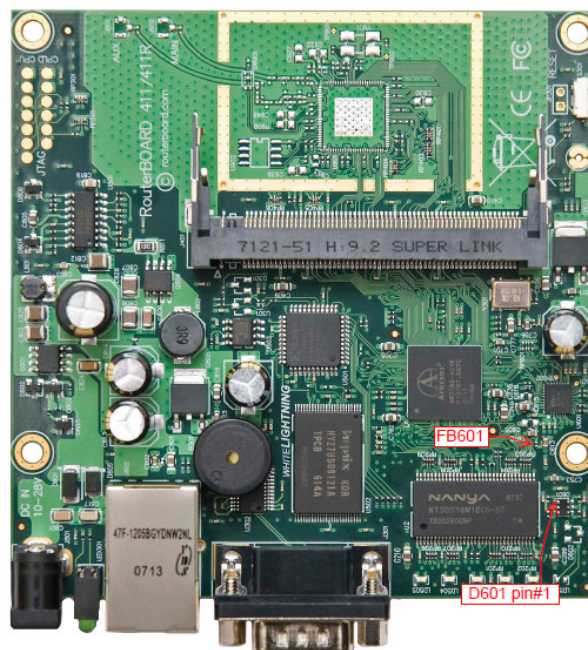
Example, in the RB411 the resistance between TX/RX and ground you can measure resistance between D601 pin#1 and ground (see attachment file).
